Manhole Inspection Summary

Manhole # S21AA_060MH

Insp Date: **10/26/07 10:01 AM**

Location Address: **810 ALLEY-LAFAYETTE-LANVALE** Cross Street: **MCKEAN-FULTON**

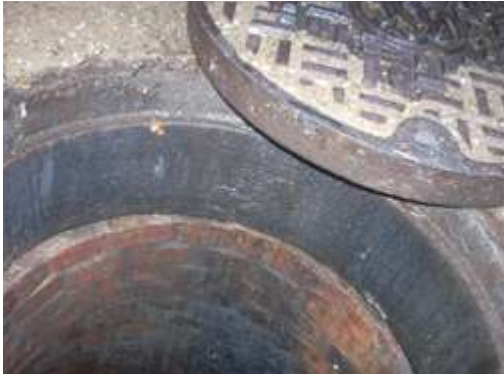
Defect 2

Corbel Material: **Brick** ☐ Parged Type: **Concentric/Eccentric**
Condition: ☐ Sound ☐ Cracked ☐ Root Intrusion ☐ Loose Brick ☒ **Deteriorated**
Infiltration: ☐ None ☐ Joint ☐ Cracks ☐ Mortar ☐ Roots ☒ **Wall**

INFILTRATION OF CORBEL

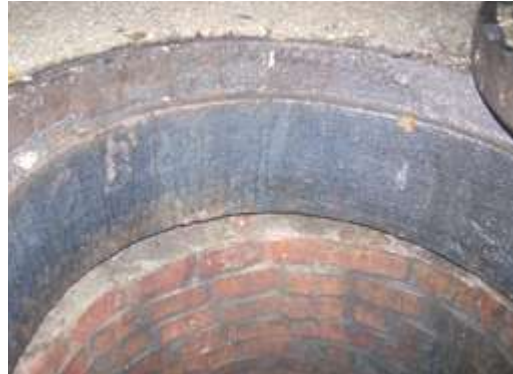
Defect 1

DETERIORATED CORBEL

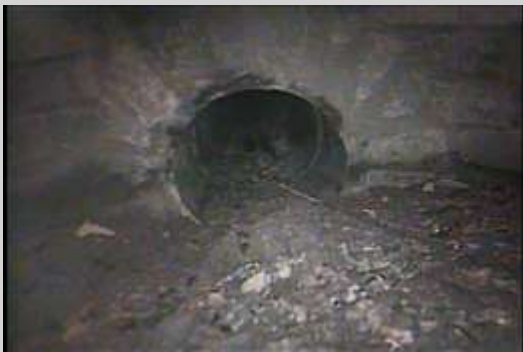
12 O'Clock Outflow

8 in. Circular Gravity Sewer
Pipe Out @ 12 O'Clock

Deposits: ☐ None ☐ Mud ☐ Sludge ☒ **Debris** ☐ Grease

Silt Depth: **1** (in.) Deposits Extent: **Light**
